Service installation of hardtop

Work to be completed

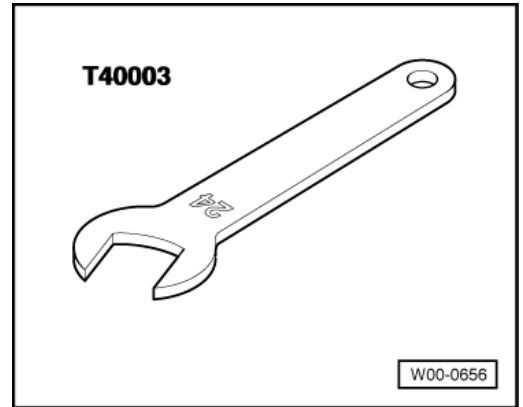
Assembly tool

Tool kit with assembly tool is part of service installation kit => Page 61-144.

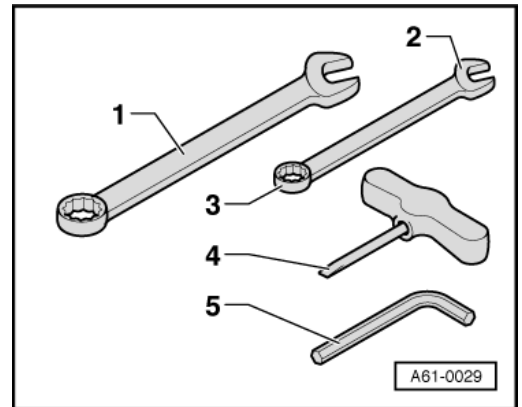
- 1 - 17 mm ring/open-ended spanner
- 2 - 11 mm open-ended spanner
- 3 - 10 mm ring spanner
- 4 - T-handle key
- 5 - Allen key
